**Patuxent Valley Middle School**  
**Assessment of Needs**

**March 2013**

Prepared for the:  
**Howard County Public School System**  
**Board of Education**  
10910 Maryland 108  
Ellicott City, MD 21042

By:  
**Gilbert Architects Inc.**  
10451 Mill Run Circle, Suite 400  
Owings Mills, MD 21117

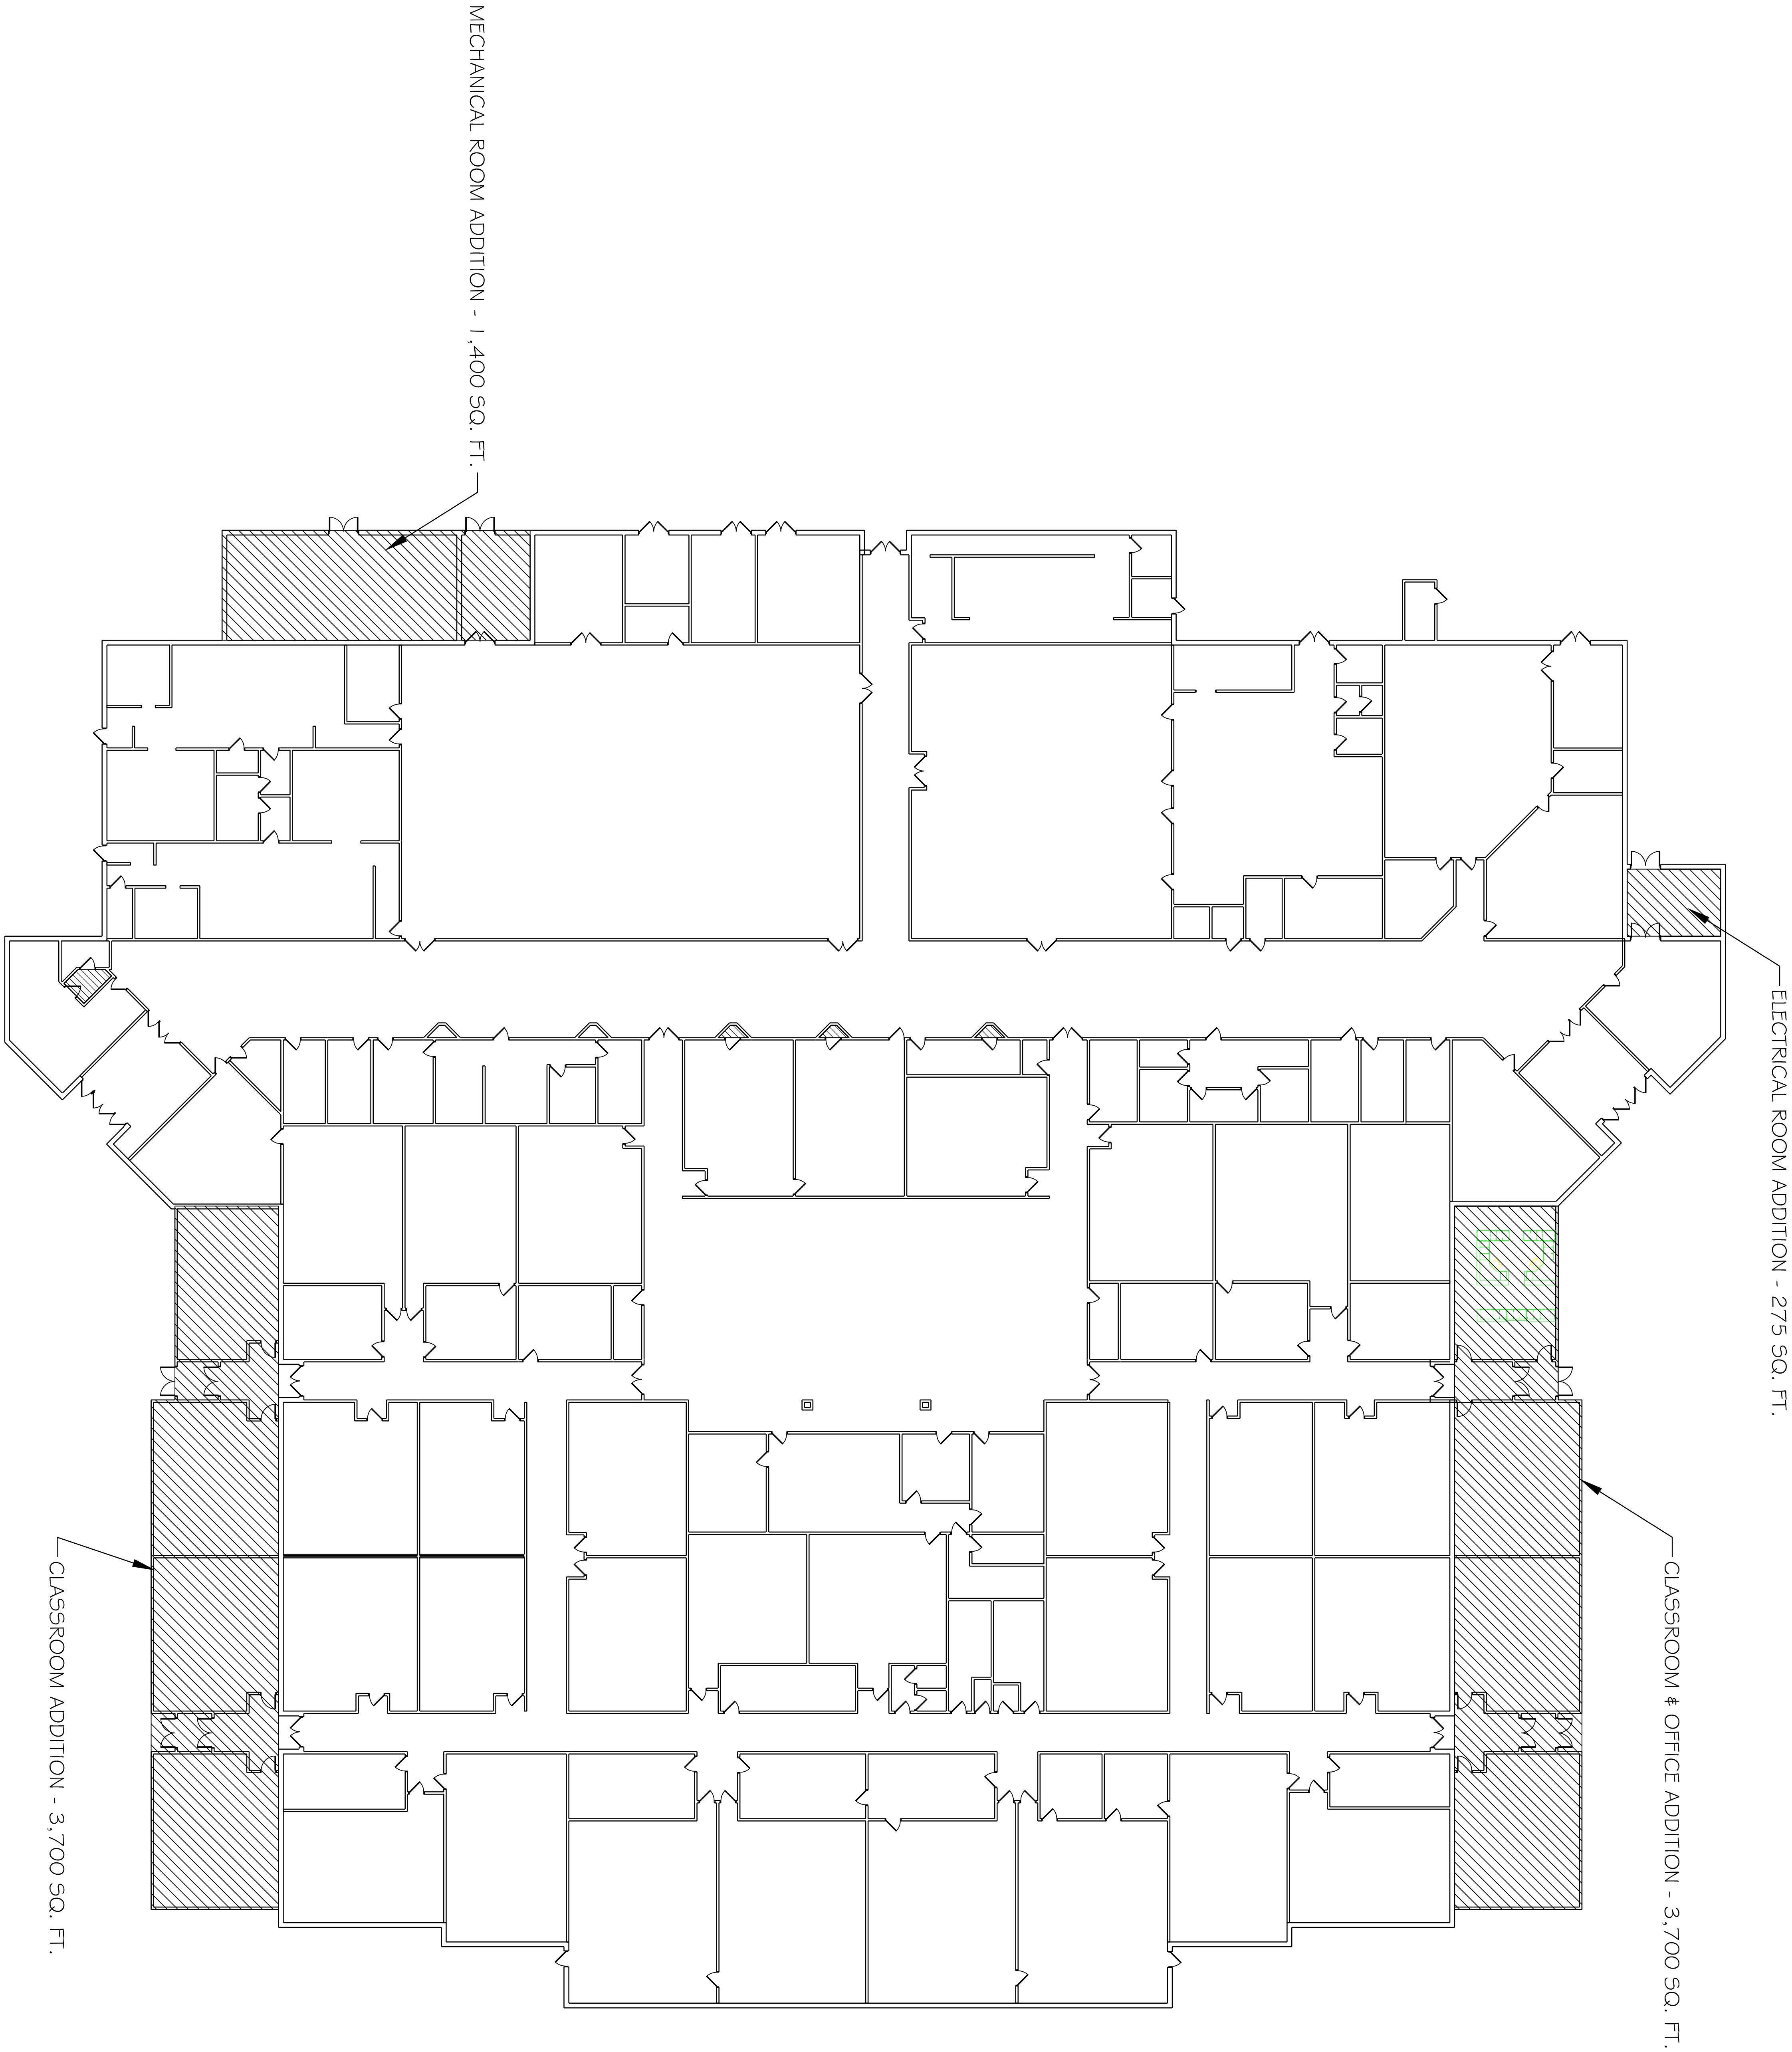
Option C appears to be the most logical approach and is recommended for consideration. A proposed floor plan and estimate of probable project costs are attached herein for review.

| - Exhibit A: Option 3 Proposed Floor Plan | |
